ANCHOR CHURCH DERBYSHIRE: CAVE HERMITAGE OR SUMMER-HOUSE? A CASE STUDY IN UNDERSTANDING A ROCK-CUT BUILDING

ABSTRACT

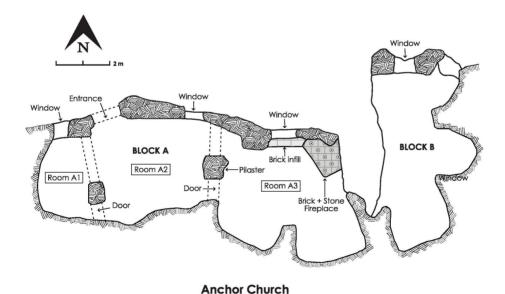
Figure 2. Sketch plan of Anchor Church showing blocks and rooms.

There are now two main spaces within the rock, to west is the largest cave (Block A) which now houses an irregular single chamber supported by two pillars. To the east is a smaller cave (Block B) which houses an irregular sub-rectangular chamber and is divided from the main cave by a natural vertical fissure in the rock face (Figure 3).

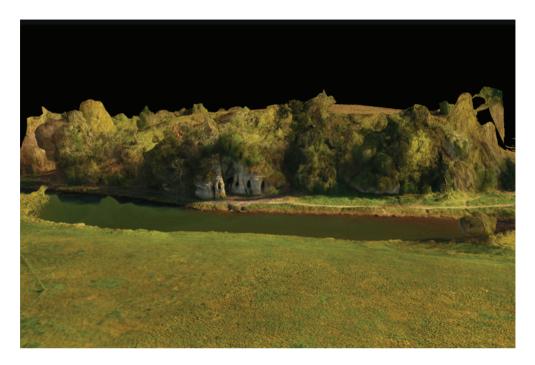
Figure 3. Rectified drone image of the site, showing site and surrounding river cliff setting.

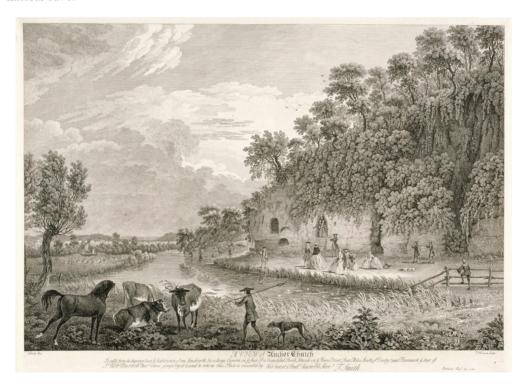
Figure 4 A View of Anchor Church, published 25 August 1745 After Thomas Smith of Derby.

Historic illustrations show that Block A retained its west wall (with a now lost large arch) until 1745. The wall has been deliberately cut away after this date and the straight scar caused by its removal can be seen on the north-west corner of the opening (Figure 8).

What is clear from the 1745 painting (Figure 4) is that the cave is, externally, substantially much as it is today. We do know the site was used by the 4th Baronet and by his son the 5th (1770-1844). They are both credited with having constructed or enlarged the site and the general assumption has always been that the fabric is mostly 18th century in origin. The drawing is diametrically correct, and apart from some drafting errors, Smith was not prone to exaggeration⁷, what is significant is that he appears to be showing the site, before any suggested alterations in the late 18th or early 19th century. Such grottoes were a fashionable part of the picturesque movement and were intended for entertaining with music, storytelling, drinking and dining. It is notable Foremarke Hall had at Anchor a ready-made grotto, whereas neighbouring Calke Abbey had to build an artificial above ground one in 1809 (Simons and Watson, 2008).

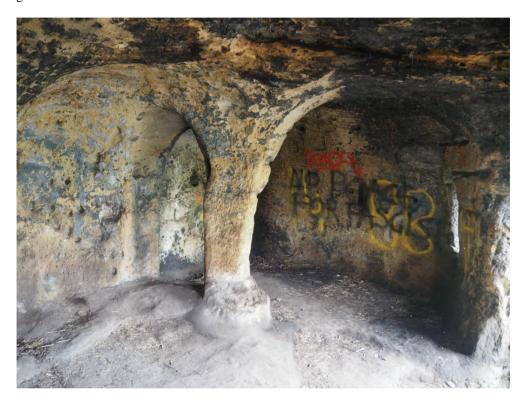
Figure 5. Former dividing wall between rooms A1 and A2. The door (complete with bolt hole and channel for frame is on the left side, the opening on the right is the result of demolition.

Room A1 is at the west end of the structure and was entered from room A2 by a narrow arched headed doorway on the inner (south wall). This doorway retains a channel for a timber door frame and a bolt hole on the inner side. It has an irregular curving outer (west) wall pierced by a single small rectangular light in the outer wall. The former stone partition wall between this room and A2 is now lost but can be traced on the floor and roof (Figure 5). This wall was later replaced in brick (1888), but there are a number of horizontal scars and sockets on the sides of the pillar and on the external wall. These look very like scars seen at other rock-cut sites which housed shelving, this does not appear to be the case here however, and they may relate to an earlier wooden partition which predated the brick wall, but post-dated the loss of the stone partition.

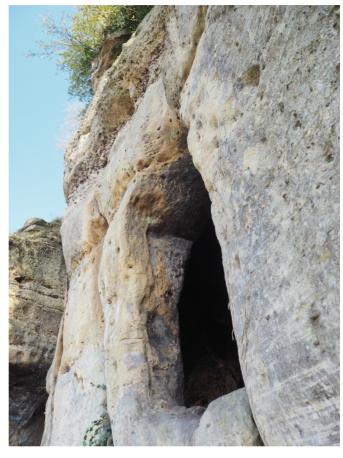
The niches in Room Figure 6. Window to Room A2, note probable remnant of a A3 and in Block B appear to small arched window on the top left-hand side of the

Room A2 houses the principal entrance to the structure, through the substantial rounded headed door and steps leading up from below. The room is lit by a large rectangular window on its outer (northern) side which has channels for a timber window frame and 18th or early 19th century brick at the base. On the external face the neatly dressed jamb and half the arch of a very much smaller and higher window can be seen (Figure 6). There is an L shaped channel in the floor which may relate to a former fixture or fitting.

The survival of fabric which demonstrates a medieval origin is also shown in what remains of the windows. Apart from the small rectangular window in A1, the other windows have clearly been enlarged and then reduced and altered on several occasions. The fragmentary, neatly dressed, small arch high on the window in A2 must, however, be a primary feature and seems to indicate that the space was lit by a small round headed light high on the wall.⁵

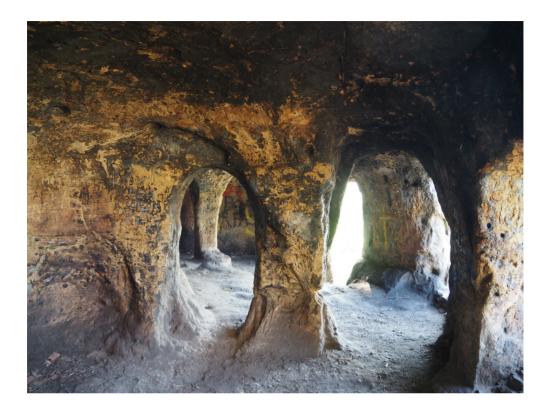
Figure 7. The pillar between Room A2 and A3, viewed from A3. The door is on the left and the opening on the right is the result of a later demolition, being punched through the thin wall of a former blind arch. The arches spring from a crude, but very obvious pilaster cap on what is now a column.

To the centre of the former wall, the pillar created by the removal of the north part of the wall includes a small part of the thin dividing wall which survived demolition (the marks of crowbars or picks relating to the removal of the wall are still visible here). To the centre of this wall is a pilaster, this has suffered much at the base, but it retains a pilaster capital from which spring two arches, one containing the narrow door and the other what was clearly once a blind arch the rear of which was formed by the lost thin partition wall. The capital has a faint roll moulding along the top and despite damage both above and below it remains remarkably intact (Figure 7).

The suggestion of an early origin of the spaces is particularly reinforced by the pilaster capital in Room A3. this is again a Romanesque feature and points to at least a 12th century origin for the main structure.

Although battered and crude, the pilaster cap in Room A3 from which springs a simple double arch may be the most telling diagnostic feature. It has a very worn roll moulding along its top and is very Anglo Saxon in appearance. There are many similar examples, the nearest being in the same parish and supporting the early 7th century Baptistry/ Crypt at Saint Wystan's Repton. This may be a coincidence, but one must ask whether this pilaster imitated the crypt or was even constructed by the same hand.

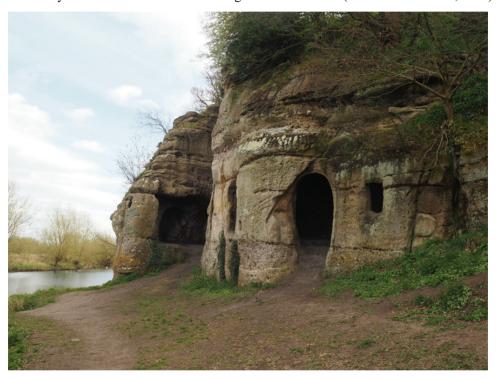
Figure 8. Exterior view of Blocks A and B, looking from the west. Compare with Figure 4, to show the former entrance and the now buried base of the cliff.
